# PROJECT REPRESENTATIVE'S DAILY REPORT

Pg. 1  
Report No. 079  
Date: 2014-12-10  
Day: Wednesday

**Project:** Renovation and Addition to Tewksbury Town Hall

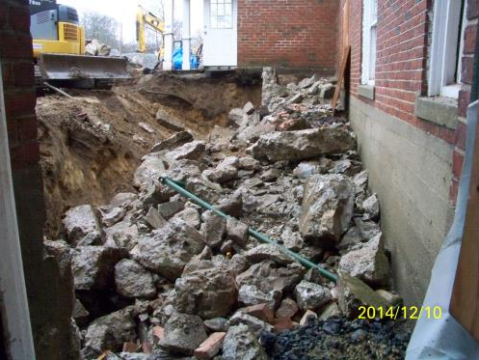
<p>Photo showing excavation for the foundation started along the south elevation of the meeting hall.</p>
 	<p>Photo showing the concrete ramp and retaining wall in the process of being demolished.</p>

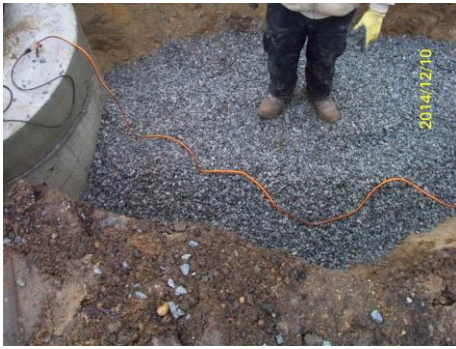
<p>Photo showing the retaining wall completely demolished.</p>
 	<p>Photo showing the drain manhole being set into place in the parking lot.</p>

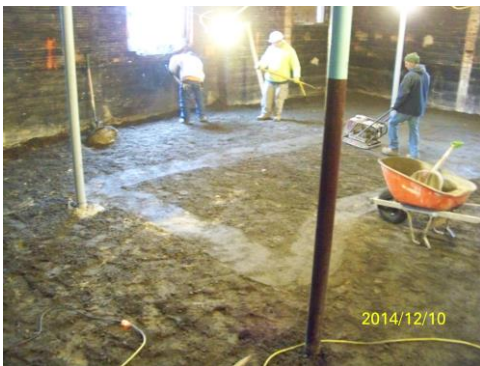
Photo showing workman placing back fill in the basement.

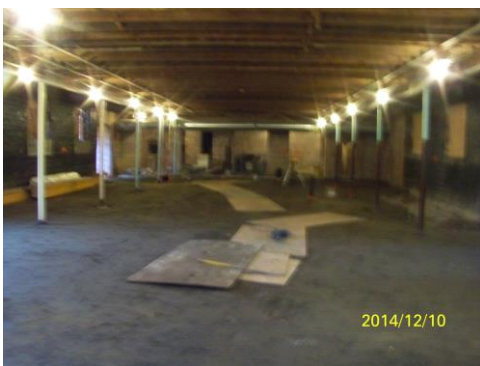
Photo showing workmen placing back fill in the basement and compacting the fill.

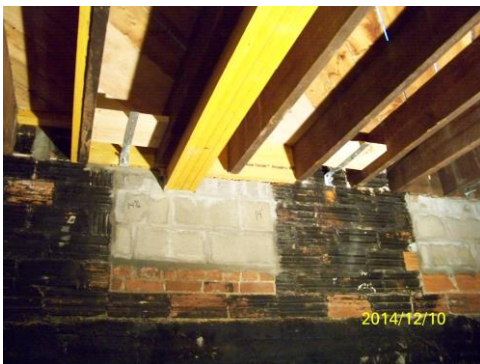
Photo showing the framing for the 2<sup>nd</sup> floor being put into place.
